Manhole Inspection Summary

Manhole # S33EE1022MH

Insp Date: **3/6/07 1:38 PM**

Location Address: **3800 39TH ST**

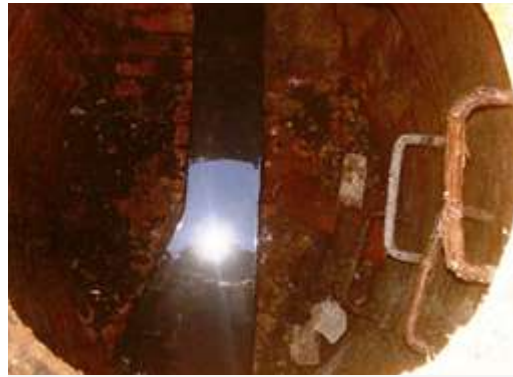
Top View

☒ **Debris** (not Condition related)

☒ **Corroded**

Corroded steps. Bench and Channel debris.

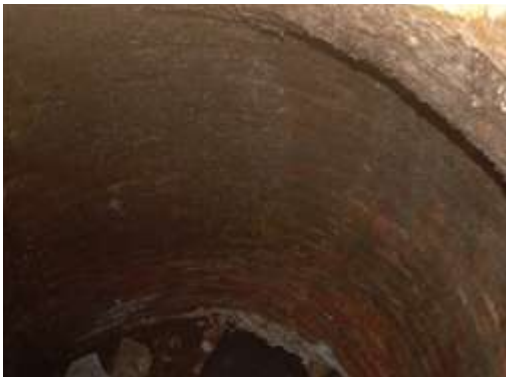
Defect

☒ **Leaks**

Infiltration: ☐ None ☒ **Joint** ☐ Cracks ☐ Mortar ☐ Roots ☒ **Wall**

Frame leaks. Adjustment infiltration.

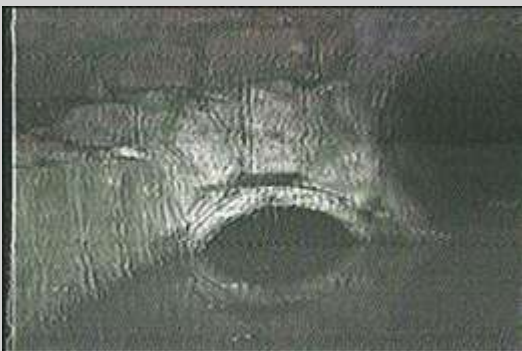
8 in. Circular Gravity Sewer Pipe In @ 6 O'Clock

Infiltration: **None** Pipe Seal Cond: **Broken**
